Special Report 78-7

FRESH WATER SUPPLY FOR A VILLAGE SURROUNDED BY SALT WATER

POINT HOPE, ALASKA

**CORPS OF ENGINEERS, U.S. ARMY
COLD REGIONS RESEARCH AND ENGINEERING LABORATORY
HANOVER, NEW HAMPSHIRE**

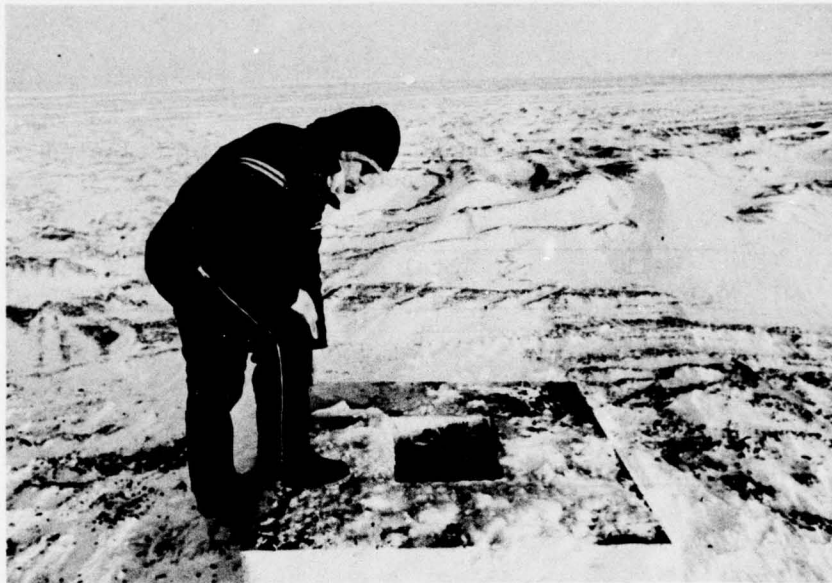
Figure 3. Surface water well in the gravel of the spit.
Note well is enclosed to protect well from
contamination.

On the basis of trip reports and visits to the village, it was determined that two possible water supplies might be developed. The first was the water which was known to exist in the gravel at a depth of approximately 3 ft (1 m) and was currently being used by the school and village for summer water supply (Fig. 3). The second was from small lakes which are located at the mainland end of the spit, a distance of approximately four miles from the village (Lakes 1 and 2, Figs. 2 and 4). The third was from Teshekpak Lake, a large lake located approximately six miles east of the village.

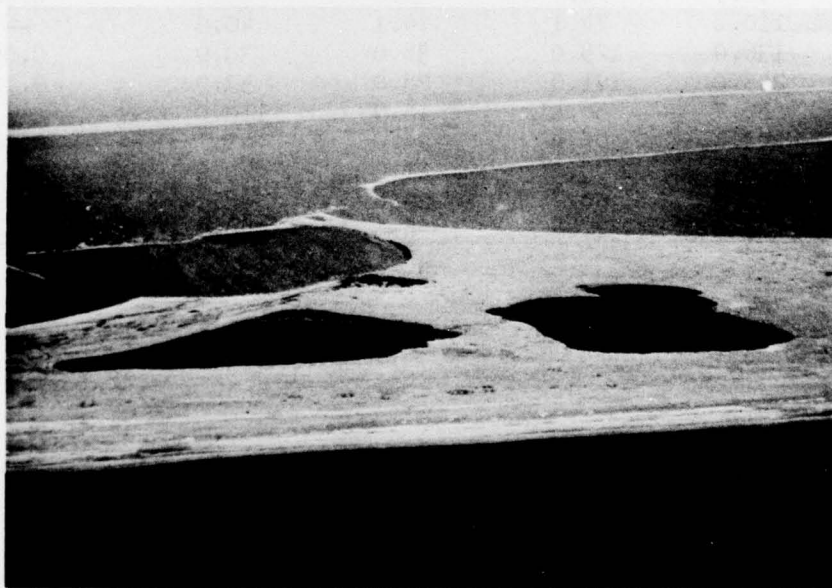
Figure 4. Small lakes at the east end of the spit.

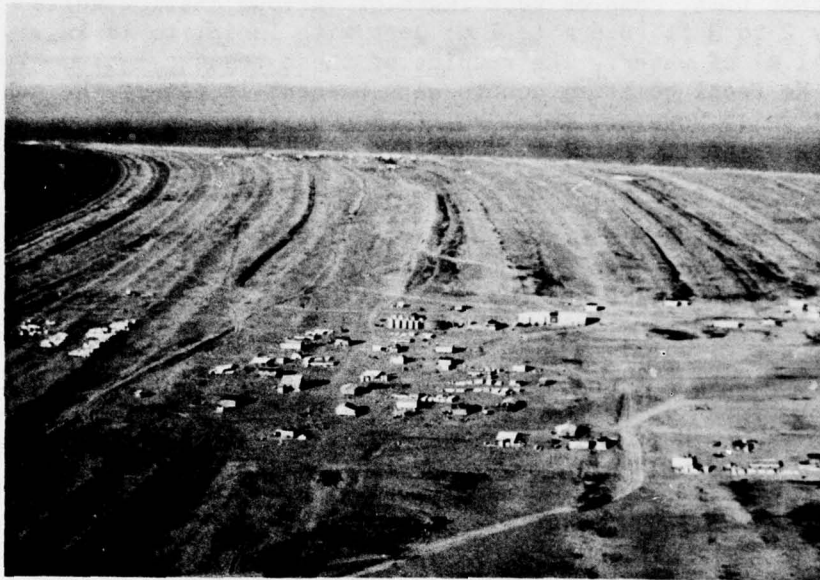
Figure 5. View of Pt. Hope spit showing gravel ridges.

The spit is composed of long gravel ridges which run parallel to the ocean (Fig. 5). Between these ridges are small channel-like depressions. The active layer in the spit is approximately the same thickness throughout the gravel areas of the spit. Thus, the surface of the permafrost table is parallel to the gravel surface, and is also composed of a series of ridges with small valleys or channels between them. These channels fill with water when the snow accumulated on the spit each winter melts during the summer.

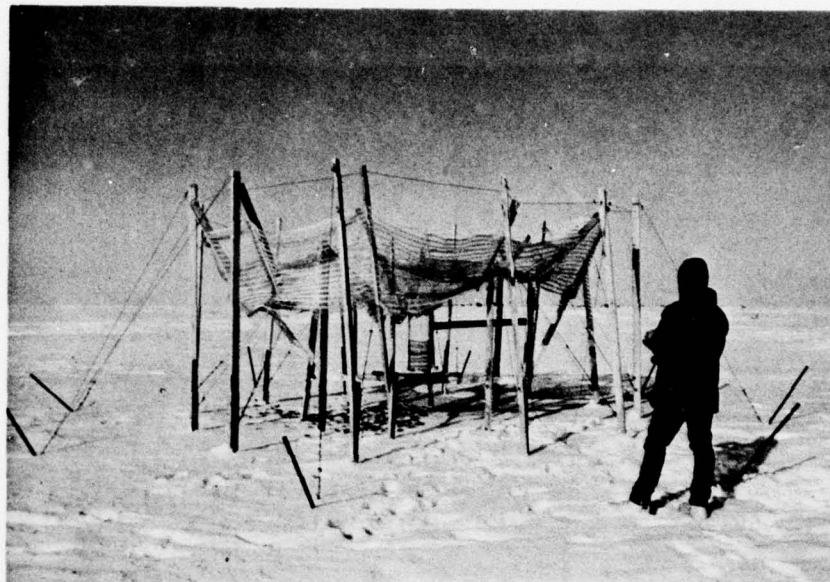
Figure 6. Wyoming snow gauge,

A preliminary investigation of the snow quantity in the vicinity of the village was done in May of 1976 to determine if snow melt water could be used to supplement the water supply. It indicated that adequate snow did exist in the area. This could be concentrated in a desired location with the use of snow fencing since blowing snow is common throughout this portion of Alaska. Since no adequate snowfall records were available for this area, a "Wyoming-type" snow gauge was erected at the site to give snowfall records for the winter of 1976-1977 (Fig. 6).

The "Wyoming" snow gauge was designed to measure snowfall in windy areas where blowing snow is a problem, and the results obtained from it gave a relatively accurate measurement of the snow available at this location. The total accumulation from 3 November 1976 to 20 April 1977, as measured by the gauge, was 1.39 in. (3.53 cm) of water equivalent.

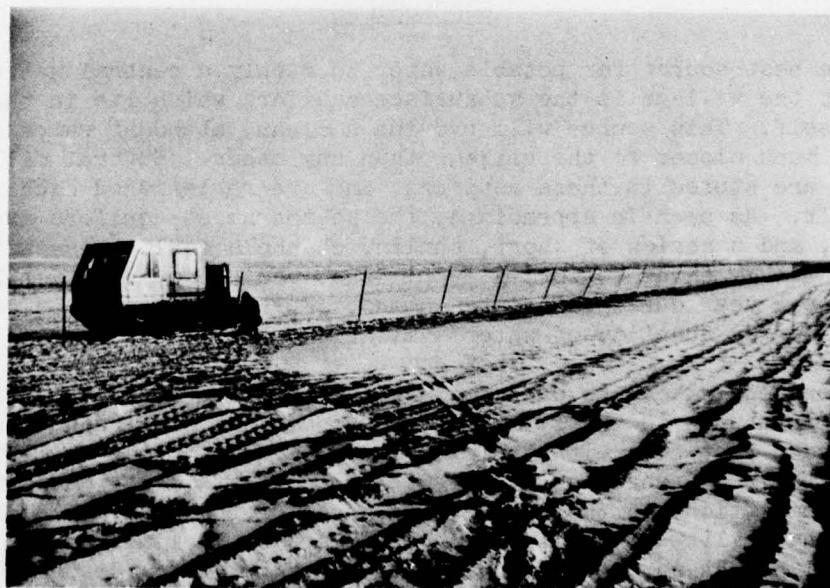
Figure 7. Installed snow fence.

In addition to the snow gauge, 666 ft (203 m) of snow fence were erected to measure the effectiveness of using a fence to accumulate snow. The snow fence was installed along the spit in an east-west direction, perpendicular to the storm winds (Figs. 7 and 8). Measurements of the depth and density of the snow drift accumulated through the winter were made in late April 1977.
